Navajo Abandoned Uranium Mine

Site Screen Report

Mine Name: Horsetrail

Mine ID: 388

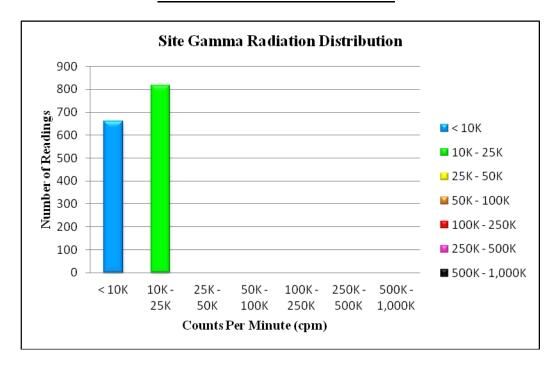
Highest gamma radiation measurement: 15,334 counts per minute (cpm)

Background Average: 9,024 cpm **Two Times Background:** 18,048 cpm

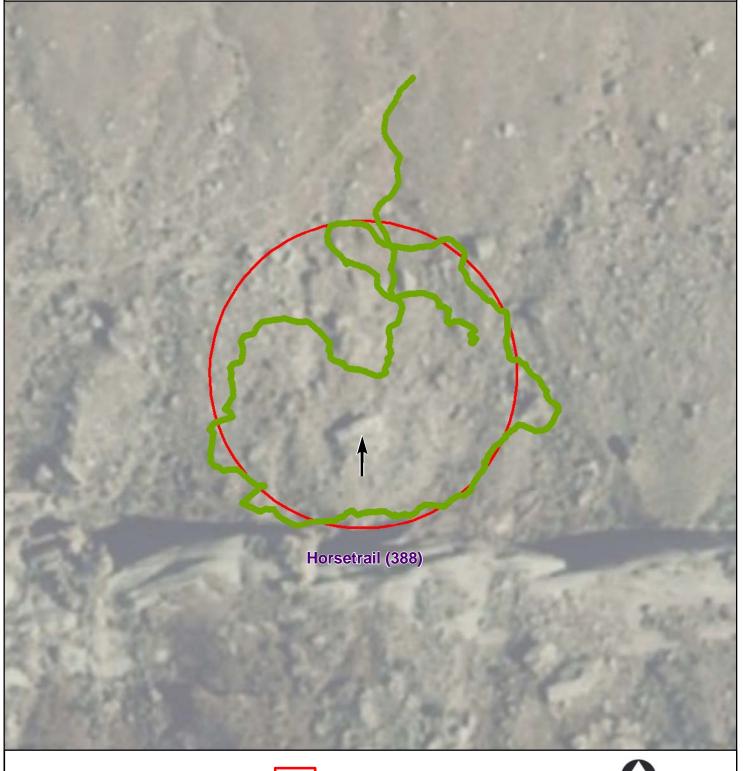
Figure 1 - Gamma Radiation Measurements, Above Two Times Background
Horsetrail (388)
Oljato Chapter, Navajo Nation

A total of 1,479 gamma radiation measurements were collected from the mine site, ranging from 4,883 cpm to 15,334 cpm. The measurements are represented in Figures 1 and 2.
